DOT/FAA/CT-86/8

# **Antimisting Fuel (AMK) Flight Degrader Development and Aircraft Fuel System Investigation**

George A. Coffinberry  
Thomas M. Tucker

Final Report

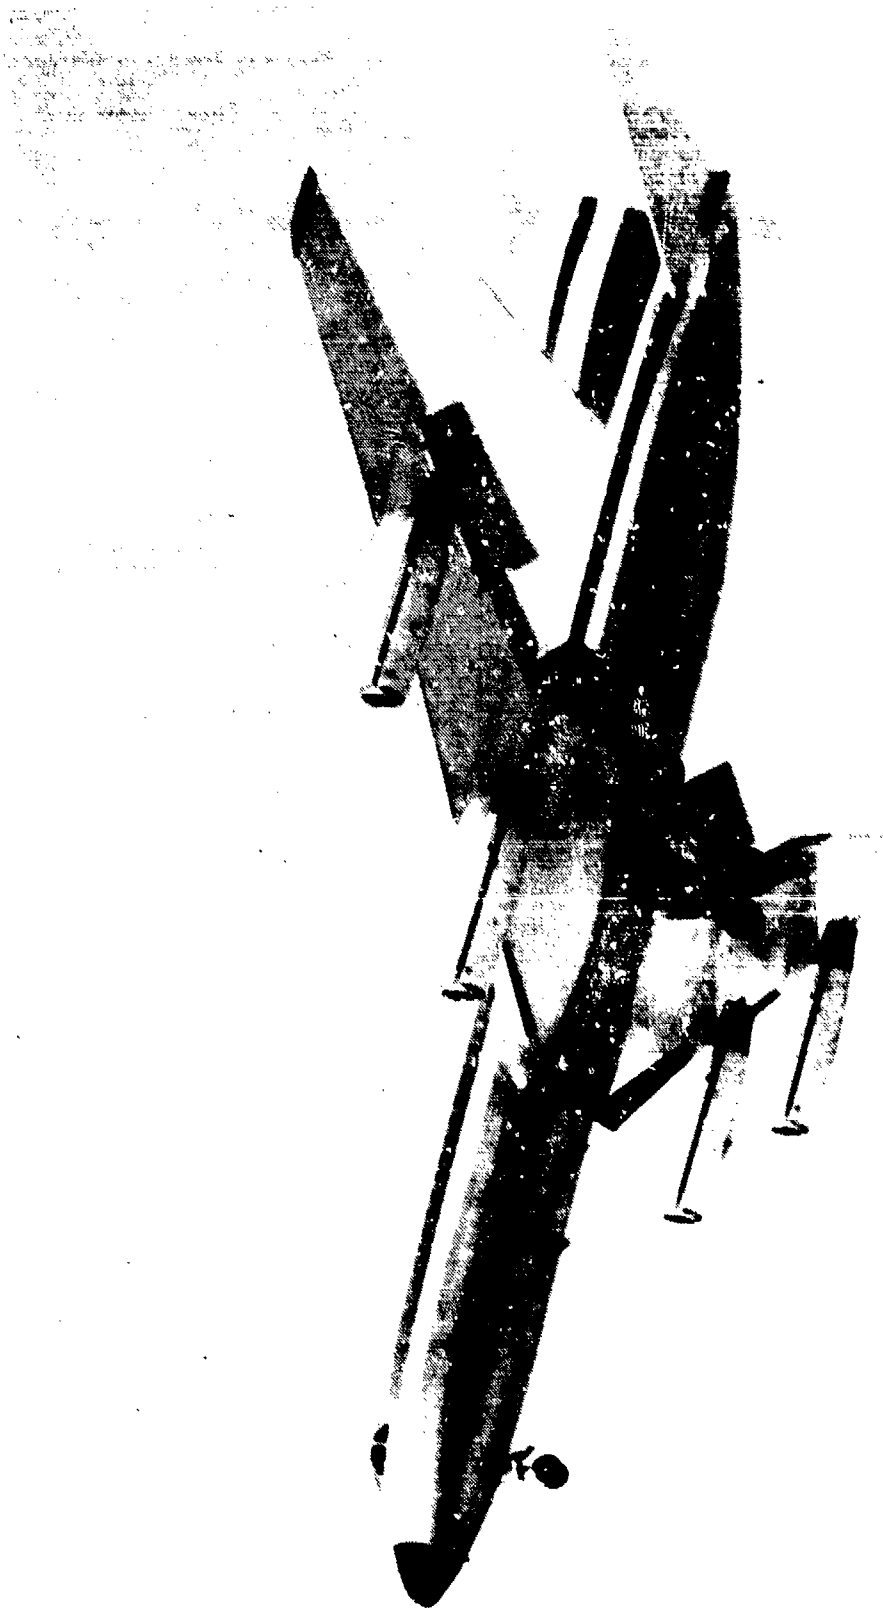
FIGURE 20. CV880 DEGRADER FLIGHT TEST VEHICLE

The aircraft used in the program was a Convair 880 Model 22M, Serial Number 048, Registration N5863. It was manufactured in August 1962. Figure 20 is a photograph of the actual aircraft. General Electric CJ805-3B engines were installed on this particular model. Prior to use in the AMK program, the airframe had accumulated 19,778 flight hours. Maintenance had been performed in accordance with FAR 91.217, and B, C, and D inspections had been performed at 19,720 hours. At the initiation of the AMK Program, the following cycles had been logged on the engines:

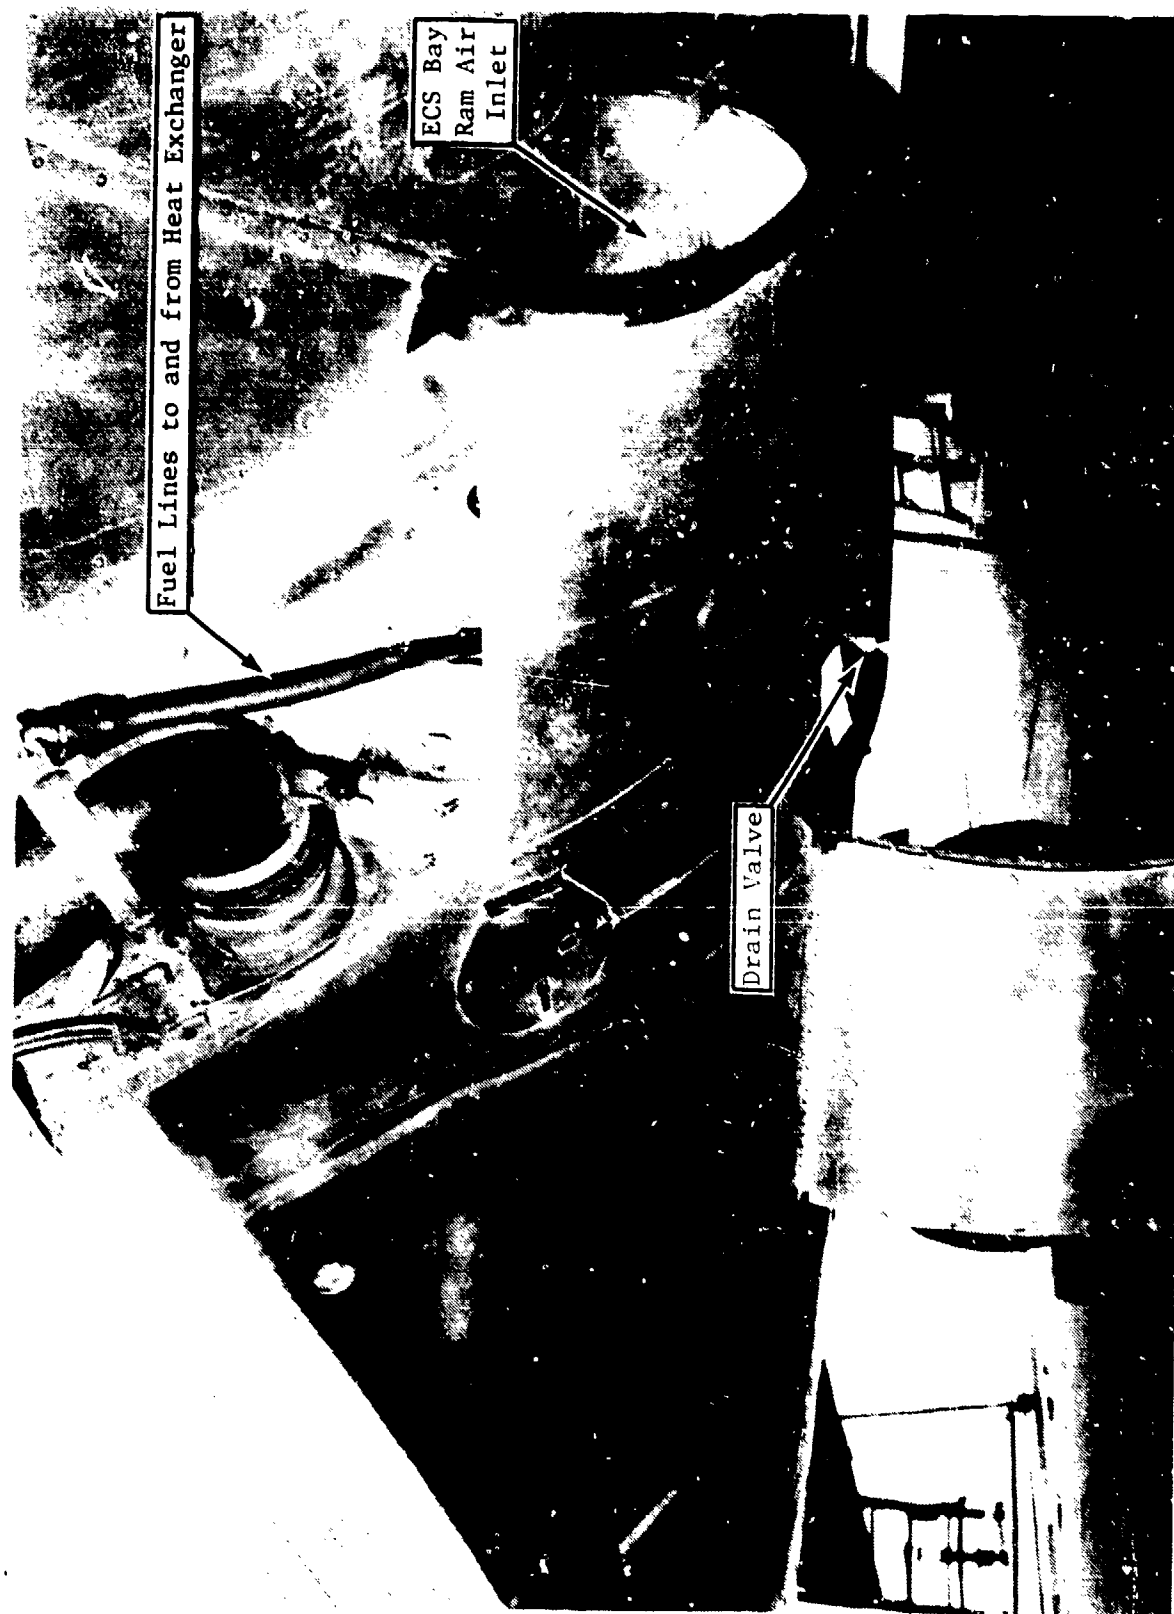
FIGURE 31. OUTSIDE VIEW OF ECS BAY

The fan and the heat exchanger installation in the aircraft ECS cooled the fuel during extended ground operation at high ambient and fuel temperatures. Figure 31 shows a drain valve that was an additional feature incorporated into the cooling loop. This drain valve permitted samples of degraded AMK to be taken on the ground, with the engine and degrader operating, without opening the engine cowl. The valve was operated by reaching inside the ECS bay air inlet scoop (Figure 32). After the fuel passed through the heat exchanger, it returned to the engine via the wing leading edge and reconnected with the fuel system supply line at the base of the engine pylon.
